TEAMSTERS CANADA RAIL CONFERENCE

USE OF JUMP SEATS

A REVIEW OF CP'S RESPONSE

BACKGROUND HISTORY & TCRC CONCERNS

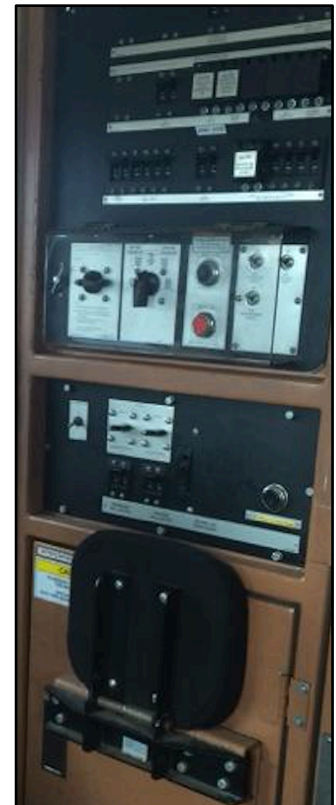
- Foam cushion was worn out,
- The back electrical panel door would not stay in the closed position,
- The pressurized car body results in cold air blowing down back or neck (this air is consist and not a part of the cab heating/cooling systems),
- Ride is extremely rough,
- No arm rests,
- No back support,
- Back/Neck/Head exposed to uneven non-padded back panel where several control knobs are located,
- In newer GE units with the retro old school AAR control stand, employee sitting in the jump seat is exposed to possible impact with the control stand during excessive slack action or if the unit is involved in a violent accident. Refer to Appendix I, and

⁴ Photo at right – standard GE jump seat in the folded position; note the placement of locomotive control switches: Source TCRC PLBO files.

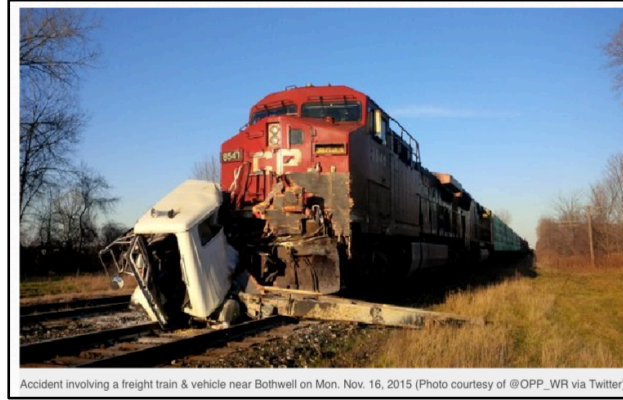
inaccessible which results in four people being required to egress by one door.⁹ Head on collisions had become a concern at Union Pacific Railroad after a crossing accident with a dump truck near Vacherie, LA, on November 30, 2000 resulted in a company officer riding in the cab being killed, Union Pacific Railroad have removed the nose door windows from all their safety cab fleet, and new units ordered do not have this option. When the door window breaks it allows collision debris to enter the cab.

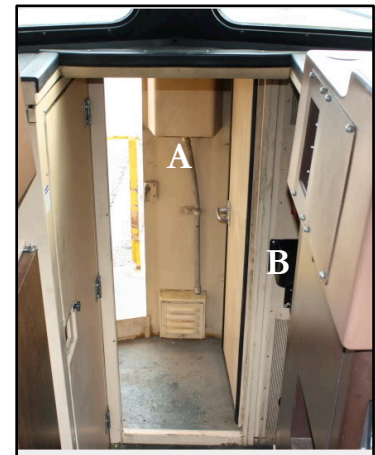
1. This location is not environmentally controlled, and exposes any grip stored there to cold or heat. Refer to photo at right letter "A".
2. This location is the normal location for the tool rack, flagging kits and the stretcher. These items are all in secured positions, which prevents them from becoming a projectile or blocking the egress route of the front door. Grips placed in this location, in an accident situation will become dislodged from their resting position and impend the egress route. The inner door opens outwards from the operating position of the cab, thus in an accident event, the inner door could become blocked, restricting the front egress route. Photo at right shows the proposed alcove storage locations for grips and the outward swing of the inner cab door. Refer to photo at right letter "A". ¹²

3. Grips placed in "the alcove directly opposite the toilet compartment door" will also have to be stacked, allowing grips to be crushed. Again, in this location during an accident event, they can become dislodged and block an egress route. Refer to photo at right letter "B".
