TEAMSTERS CANADA RAIL CONFERENCE

USE OF JUMP SEATS

A REVIEW OF CP'S RESPONSE

BACKGROUND HISTORY & TCRC CONCERNS

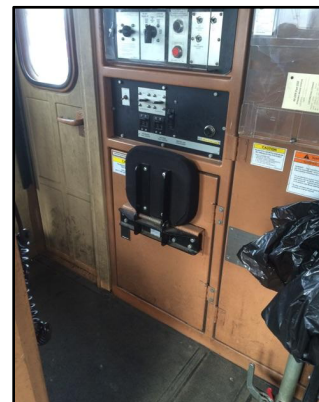
The “jump seat” is a small, spring loaded seat, that has been traditionally used by a locomotive engineer when providing training to an engineer trainee, a place for a trainee to sit and watch the engineer and/or a place for a road foreman of engines and/or other manager to observe the engineer. This seat has no back support, no arm rests, no height adjustment and/or any adjustment features. Its intended use is for short periods of time. When not in use, the spring-loaded feature of the seat, forces it in to the up right position. (see photo at right)¹

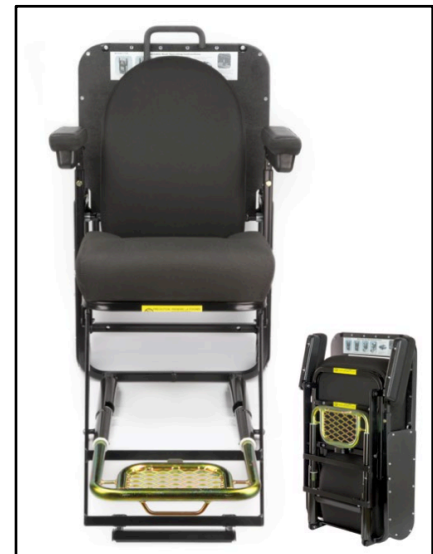
The only other seating change has been with the new revised control stand² that has appeared in newer CP/GE products. Given the very tight cab space, the third crew member seat is now a “retractable seat”, which when not in use hangs folded on the back wall. This seat is equipped with back support, armrests and a footrest. This seat is normally in the raised position when not in use. (see photo at right)³

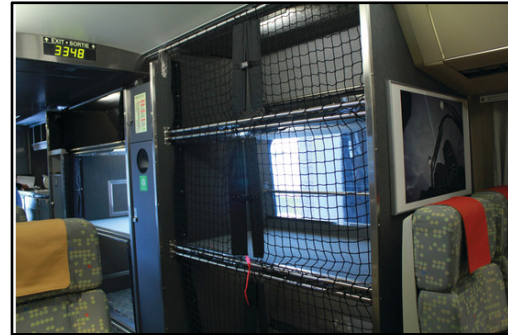
The locations identified by the company do not have any "luggage type" racks, and thus grips will have to be double stacked which can result in grips being crushed. Recently a conductor while travelling deadhead on VIA Rail, encountered an issue with their grip when the conductor was at the VIA Rail station checking in. The grip in question received secondary inspection by VIA Rail station staff, the bagged weighed in at 43 pounds, 3 pounds greater the VIA Rail's luggage regulations in the coach.

VIA RAILS policy is determined by fare, size, weight and the fact that they can be stored in a secured location – end coach rack and or overhead luggage compartment, locations designed to hold luggage and secure stored luggage in the event of an accident. Photo above shows VIA Rail end coach secure luggage location. ¹¹
